**Project Title** : Indicative Fire Test on 12 mm Thick Magboard  
S-Line Retardant Construction Board

**Client** : Magboard Benelux BV

**Reference** : P03157ASKR

An indicative fire test was performed on 12 mm thick Magboard S-Line Retardant Construction Board built onto a vertical surround comprising refractory brick and block work and held in position using a calcium silicate board beading system. The test was conducted at CERAM using the reduced scale furnace with the specimen tested to the general principles of BS 476 part 20: 1987.

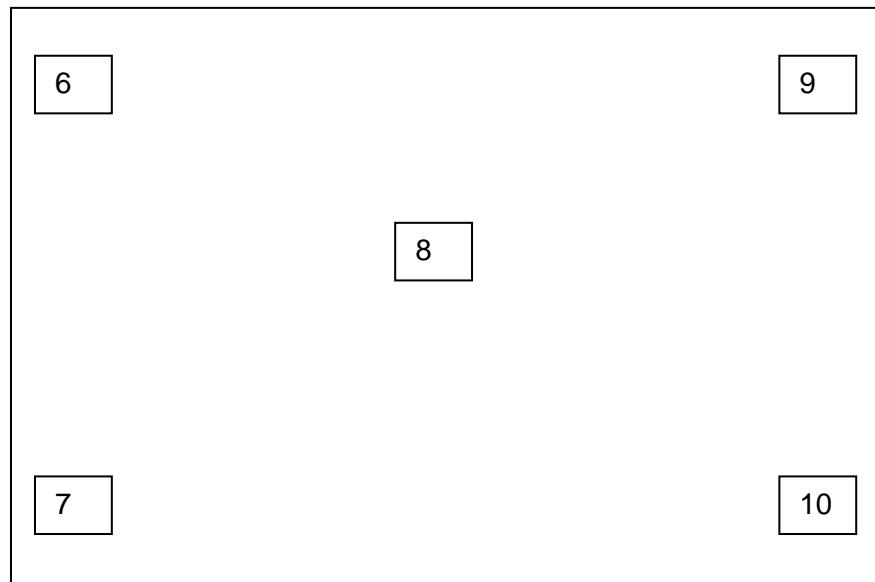
**Figure 1 - Sketch of Thermocouple Locations**

The numbers relate to the thermocouple details given in the test data section. Sketch is not to scale.

Figure 1 – APPENDIX Section shows a sketch of the panel NON-FIRE side with positions for specimen thermocouples

Specimen surface temperature (non fire side) was measured using five type K thermocouples as specified in BS 476 Part 20: 1987 section 6.4.2.1. Four thermocouples were positioned on the board face, approximately 50 mm from the panel corners and the bead joints. A fifth thermocouple was located on the centre of the panel face. Thermocouple location details are shown on the specimen sketch Figure 1 in the APPENDIX.

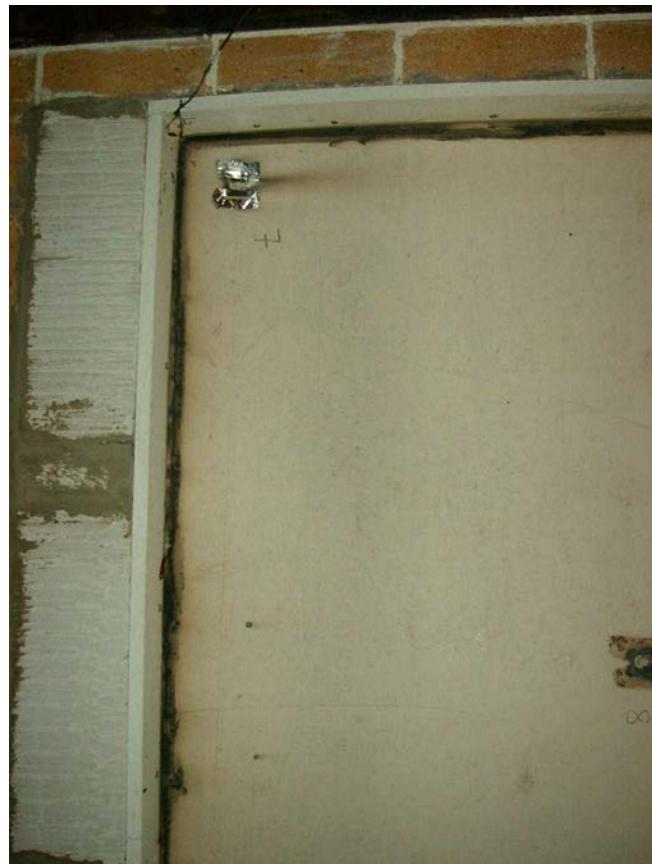
**Figure 5 – Observation at 53 Minutes**

28:30	U	7.7-9.3	All bead/panel intumescent joints now discoloured.
34:54	U	7.7-9.3	TC 6 fallen away from panel surface.
36	U	7.7-9.3	TC 7 fallen away from panel surface.
43	U	6.9-9.3	TC 8 and 10 not in contact with panel surface.
53-55	U	7.8-9.1	Figures 3 and 4 – TC 9 not in contact with panel surface.
55-100	U+E	7.6-8.7	No change
105	U	7.5-8.9	As above, Figures 5 and 6.
106	U	7.7-9	A-B bead bowing.
112	U	7.5-9.2	A-B bead bowing, two fixing pins fallen out.
116	U	8.1-9.4	Panel bowing into furnace with bow at maximum at panel centre point, bow circa 50 mm.
118	U	8.1-9	All bead/panel joints cracked.
119	U	8.3-8.5	Figure 7.
120	U	8.6-9.1	A-B bead cracked.
136	U	8.1-9.6	As above, crack opened.
145	U	8.5-9	Figure 8 showing bead joint open.
153	U	7.9-8.5	A-B bead partially separated.
154	U	7.9-8.6	Cotton pad ignited at open joint, integrity failure. Panel showing no signs of integrity damage.

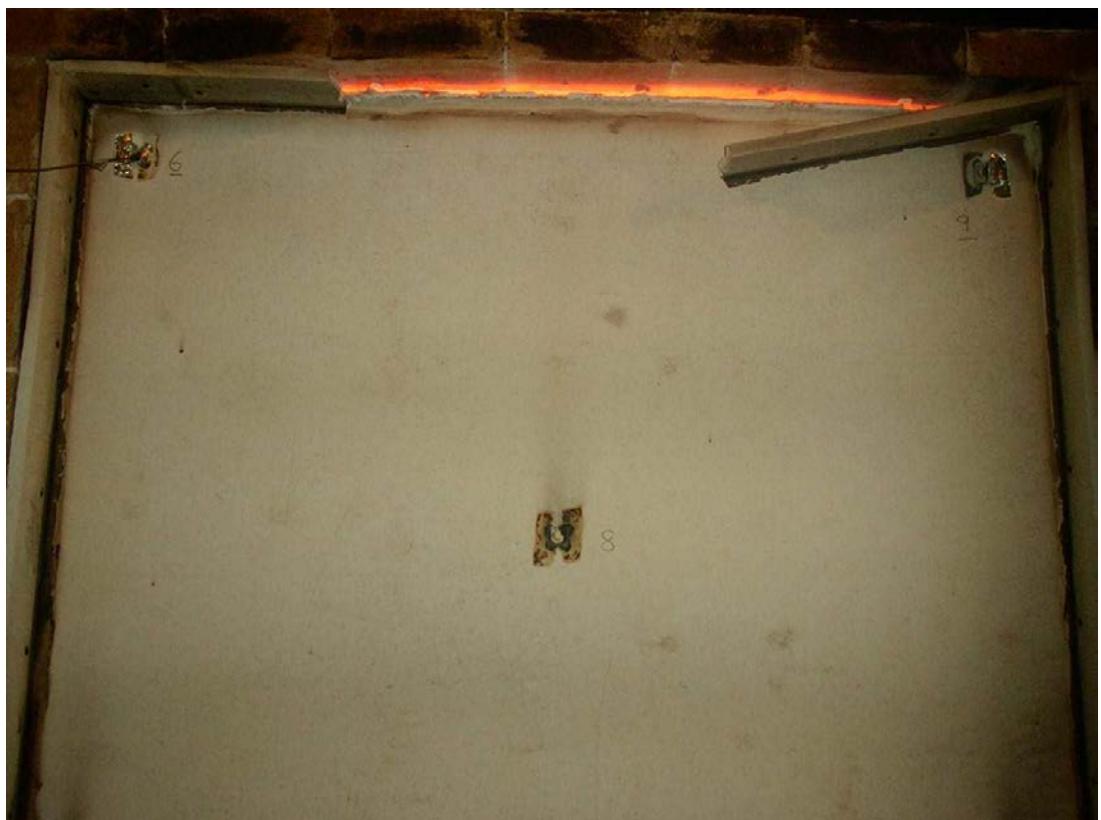
**Figure 9 – Observation at 155 Minutes**

TIME (min;sec)	FACE (U/E) *	PRESSURE (Pa)	OBSERVATION DETAILS MADE BY TEST OPERATOR
155	U	7.6-9.3	Figure 9 – test continued
173	U	8.1-8.9	No change to condition noted at 154 minutes.
180	U	8.1-8.9	As above, test terminated Figure 10.
<b>POST TEST OBSERVATIONS</b>			
The maximum bow at the specimen centre was 65 mm, no surface cracks observed on the unexposed face. The exposed face showed a vertical open crack and a blistered surface (observations seen during early test stage). Figure 11 to 14 show post test illustrations.

- A section of the said bead became detached from the test frame surround after a period of 152 minutes to reveal a fissure between the frame surround and the 12 mm thick Magboard S-Line Retardant Construction Board. At this point of proceedings, the system failed the cotton pad integrity test. It was noted that the 12 mm thick Magboard S-Line Retardant Construction Board displayed no signs of integrity damage.

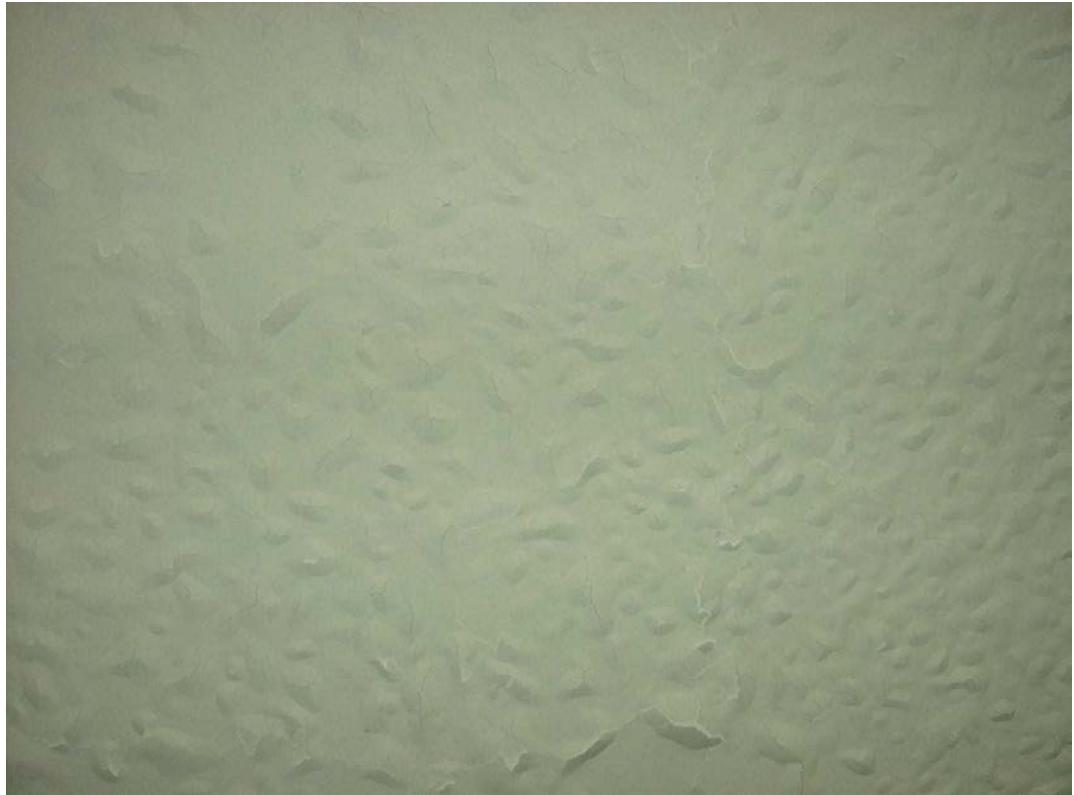
**Figure 12 – Post Test Observation Fire Side Magnified**

- After 13 minutes, the exposed face of the panel showed evidence of random surface cracks combined with a flaky appearance. After initial discolouration, this appearance was maintained throughout the test duration and is shown on the post test photograph Figure 12 in the APPENDIX.

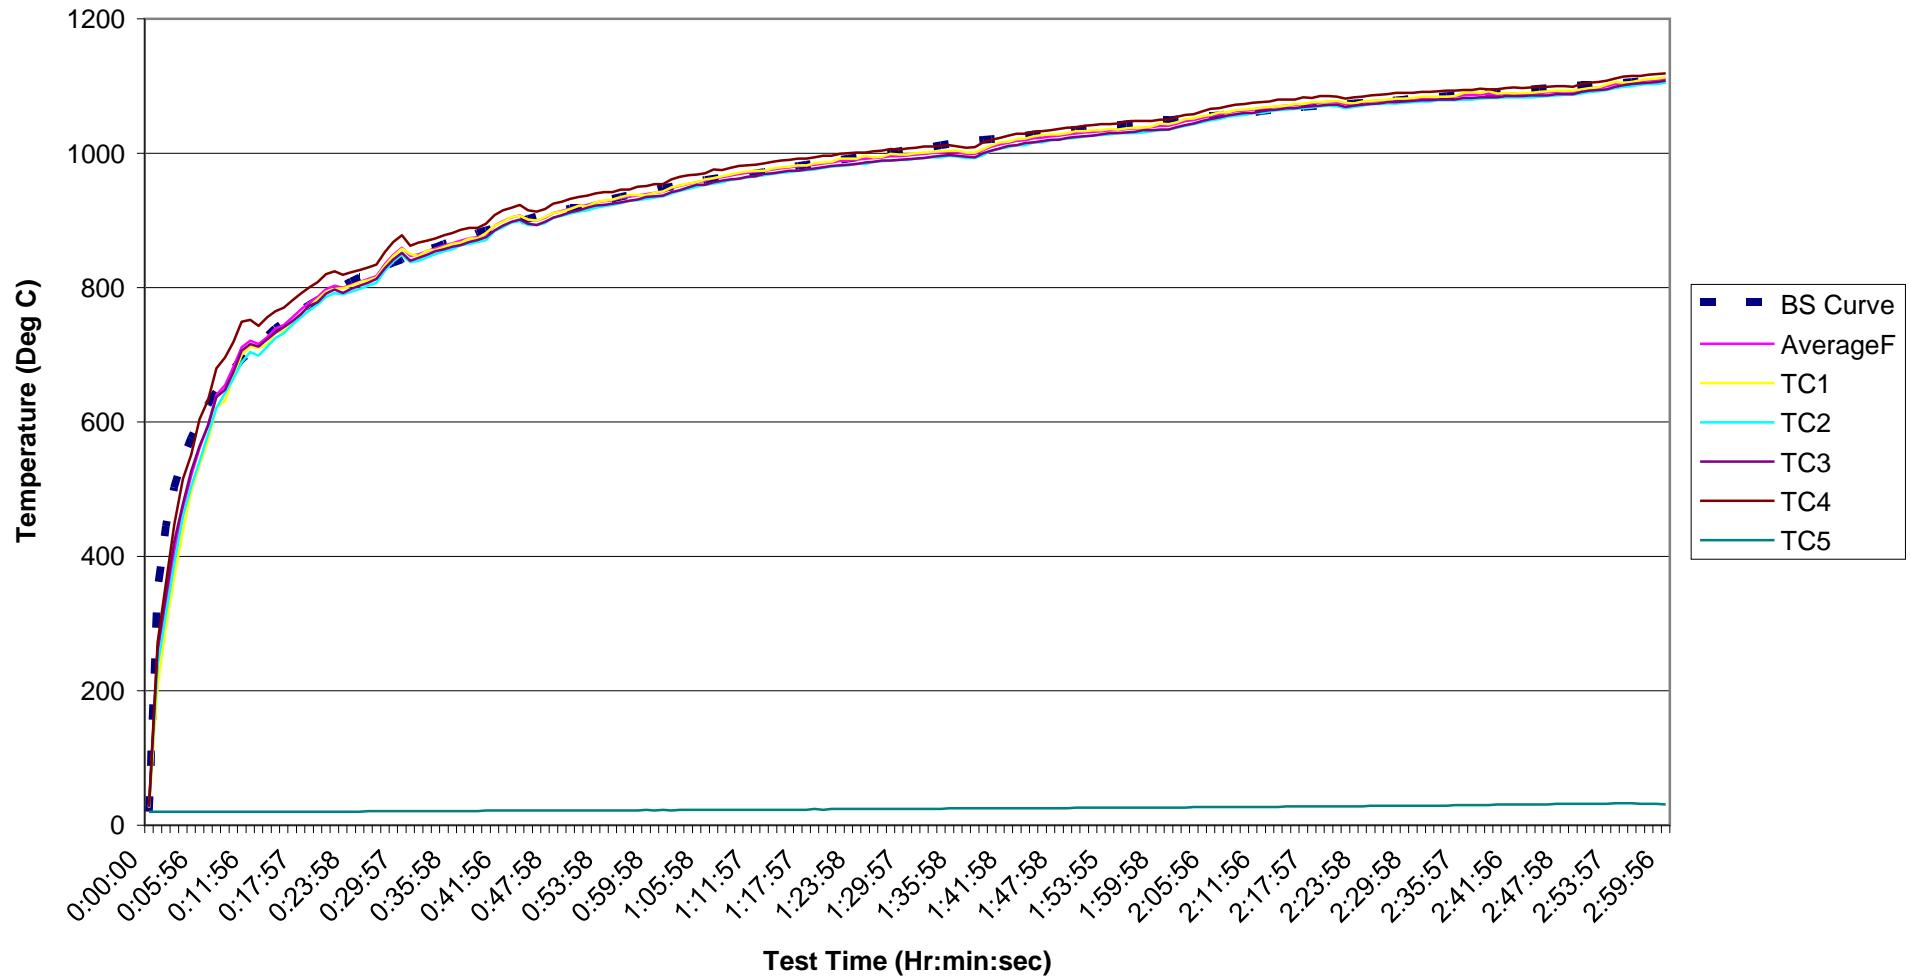
**Figure 15 - Furnace Thermocouple Data - Magboard S-Line Retardant Construction Board - CERAM Fire  
Test P03157ASKR tested 01/08/03**

Furnace temperature was monitored using four type K mineral insulated thermocouples positioned equidistantly across the furnace opening. The average temperature of the four thermocouples was controlled to the limits specified in BS 476 Part 20: 1987 and BS 476 part 22: 1987 Section 10.4.3. Recorded data is in the APPENDIX.

Time (min)	Area Std	Area actual	% Diff.	% Tol
0-10	5651	5132	-9.2	± 15
11-30	15576	15632	0.4	± 10
31-180	152075	151700	-0.2	± 5

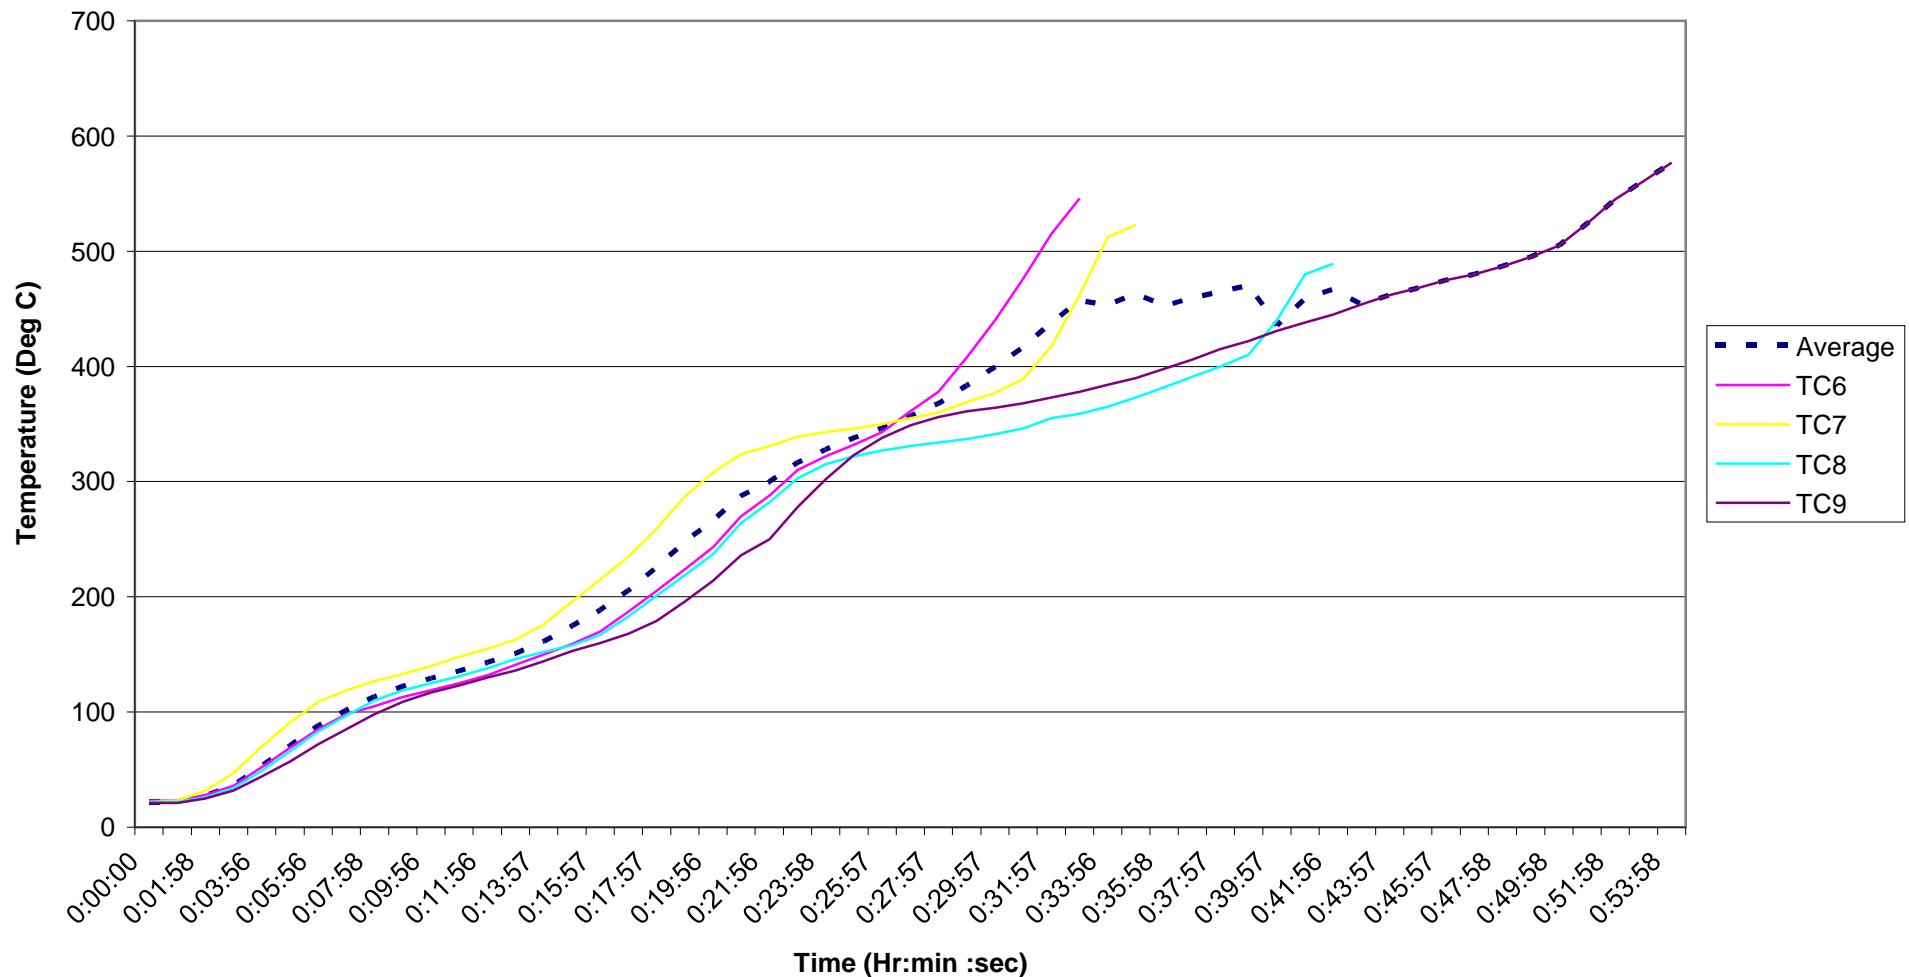
**Figure 16 - Specimen Thermocouple Data - Magboard S-Line Retardant Construction Board - CERAM  
Fire Test P03157ASKR tested 01/08/03.**

- Insulation failure occurred after 24 minutes due to: (a) the average thermocouple temperature (175°C) exceeding the maximum permissible temperature of 140°C plus ambient (22°C) and (b) Thermocouple 10 exceeding the maximum permissible temperature for a single thermocouple of 180°C plus ambient (22°C).
