Project Title : Indicative Fire Test Program

Client : Magboard Benelux BV

Reference : P04191ASKR

Two separate indicative fire tests were performed on vertical panel systems constructed on behalf of Magboard Benelux BV. Each system consisted of a single test specimen built into a blockwork frame housing. The tests were conducted at CERAM using the reduced scale furnace with each specimen tested to the general principles of BS 476 part 20: 1987.

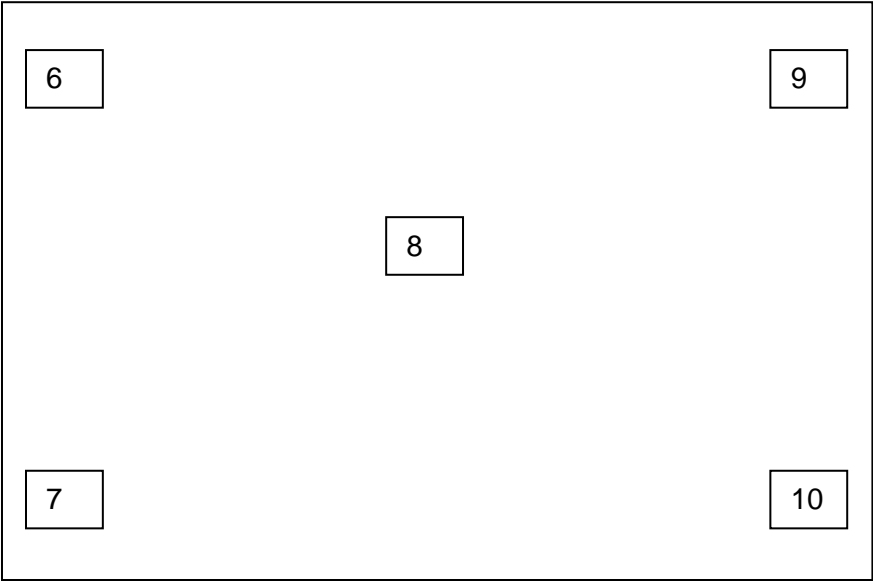
Figure 1 - Non-Fire Side of Specimen 1 - Sketch of Thermocouple Locations

Specimen surface temperature (non fire side) was measured using five type K thermocouples as specified in BS 476 Part 20: 1987 section 6.4.2.1. Four thermocouples were positioned on the board face, approximately 50 mm from the panel corners and the bead joints. A fifth thermocouple was located on the centre of the panel face. Thermocouple location details are shown on the specimen sketch Figure 1 in the APPENDIX.

The numbers relate to the thermocouple details given in the test data section. Sketch is not to scale.

Figure 1 – APPENDIX Section shows a sketch applicable to test specimen 1 showing the panel NON-FIRE side with positions for specimen thermocouples.

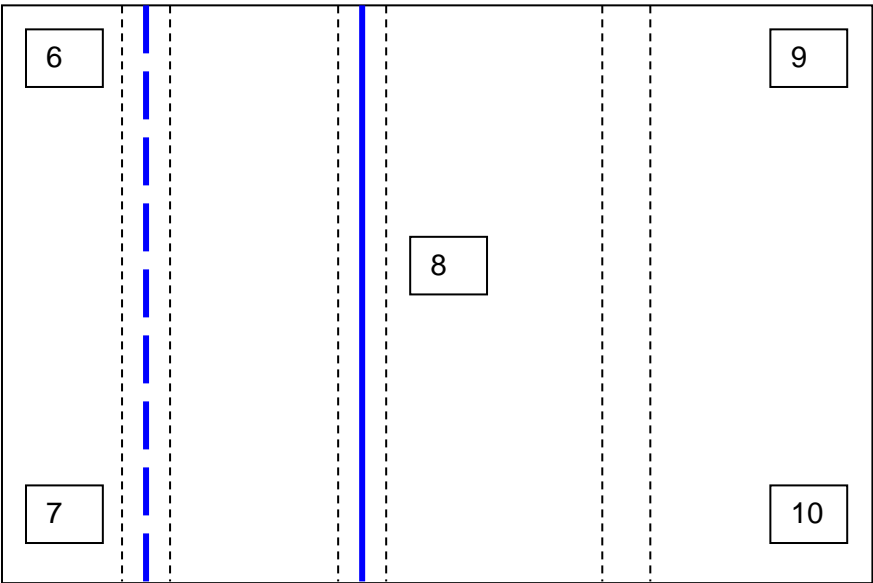
Figure 2 - Non-Fire Side of Specimen 2 - Sketch of Thermocouple Locations

Specimen surface temperature (non fire side) was measured using seven type K thermocouples as specified in BS 476 Part 20: 1987 section 6.4.2.1. Four thermocouples were positioned on the board face, approximately 50 mm from the panel corners and the bead joints. A fifth thermocouple was located on the centre of the panel face. Two additional thermocouples were positioned adjacent to the perpendicular joint. Thermocouple location details are shown on the specimen sketch Figure 2 in the APPENDIX.

The numbers relate to the thermocouple details given in the test data section. Sketch is not to scale.

— Magboard S-Line Joint - - - - - Vertical timber Centres
— Plasterboard Joint

On the fire-side face, the Magboard S-Line board was fixed using the same method but with a single intersection vertical joint set at 1200 mm from the left hand opening edge face, as viewed from the fire side. This ensured that the plasterboard and Magboard intersection joints were not in a line of symmetry from the direction of the fire. Gaps in the edges of the plasterboard/block and Magboard/block were sealed using intumescent sealant. The test specimen contained no additional insulation material with an air gap of 75 mm separating the fire-side/non fire side boards (in between the timber joints). The location of joints and timber sections is illustrated in the Figure 2 sketch (Appendix).

Figure 2 - APPENDIX Section shows a sketch of the NON FIRE side of Test Panel 2 showing the panel NON-FIRE side with positions for joints and specimen thermocouples.

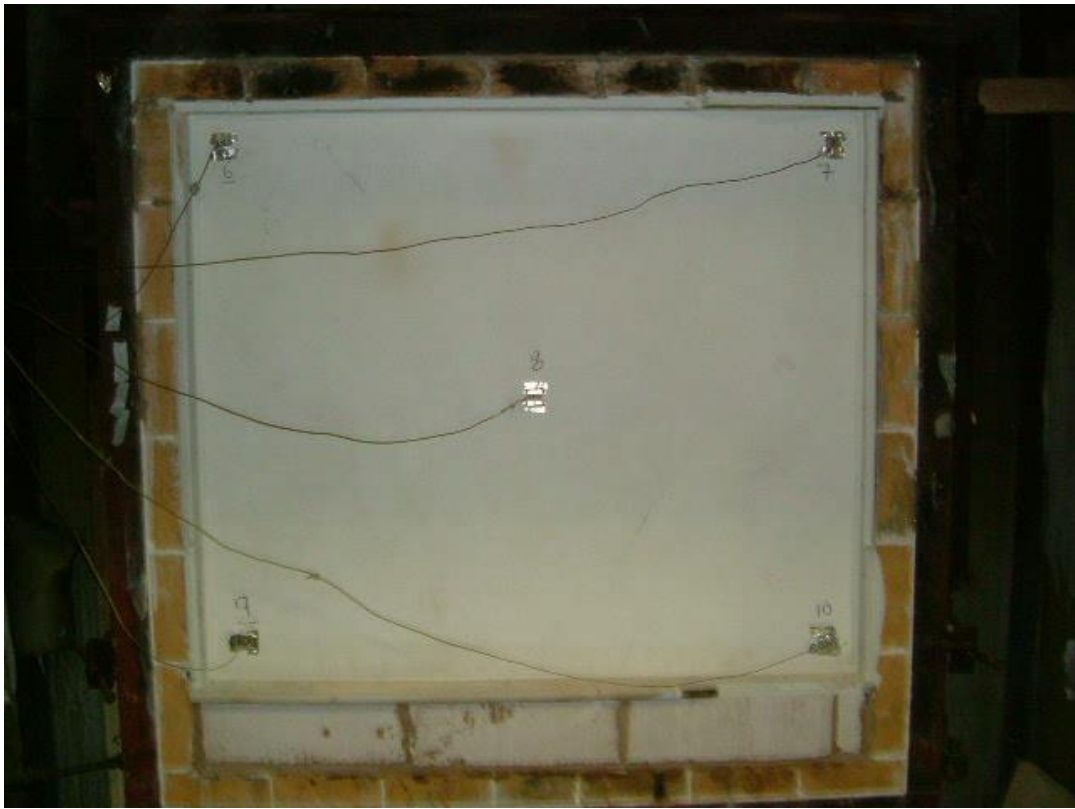
Figure 3 - Test Specimen 1 - Pre-test – Non Fire Side

Figure 3 - APPENDIX Section shows a photograph of the NON-FIRE side of Test Specimen 1 prior to test commencement.

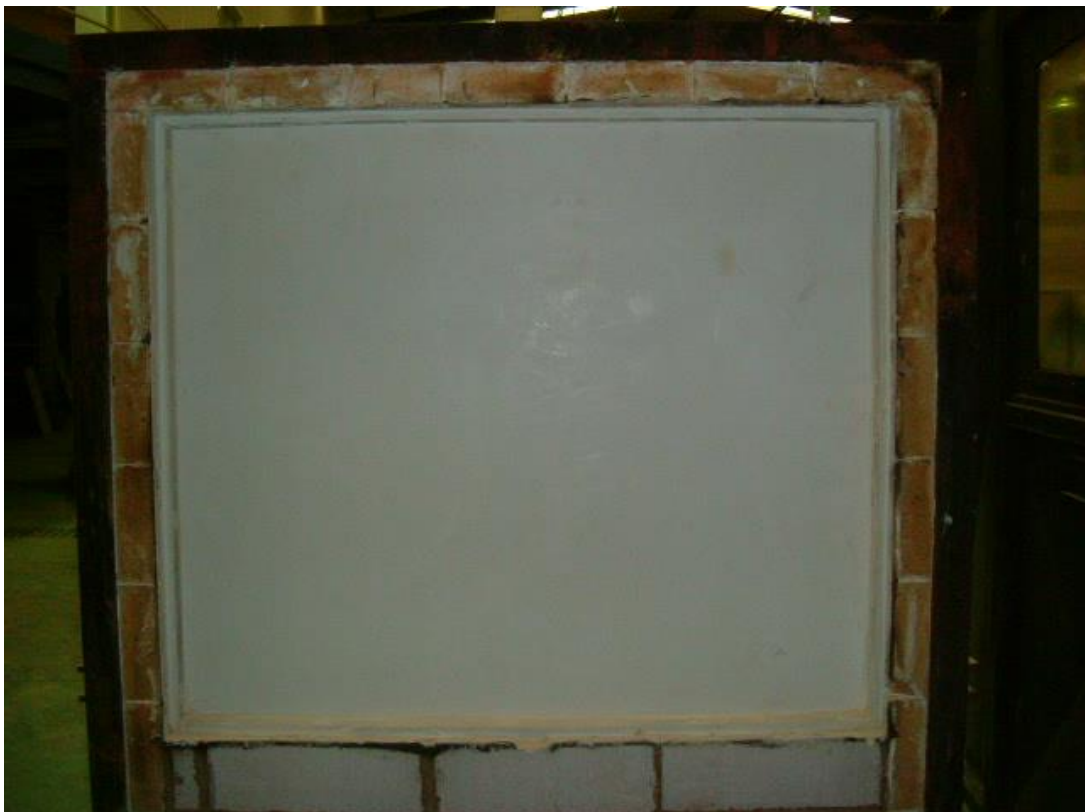
Figure 4 - Test Specimen 1 - Pre-test – Fire Side

Figure 4 - APPENDIX Section shows a photograph of the FIRE side of Test Specimen 1 prior to test commencement.

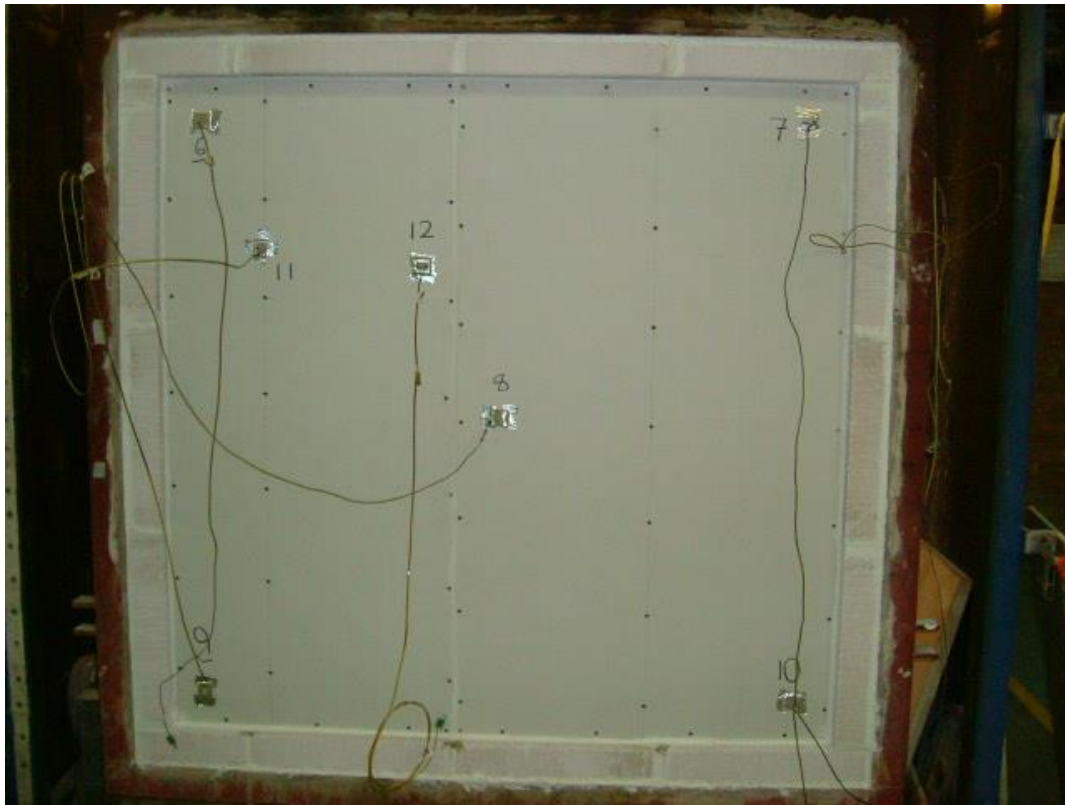
Figure 5 - Test Specimen 2 - Pre-test - Non Fire Side

Figure 5 - APPENDIX Section shows a photograph of the NON-FIRE side of Test Specimen 2 prior to test commencement.

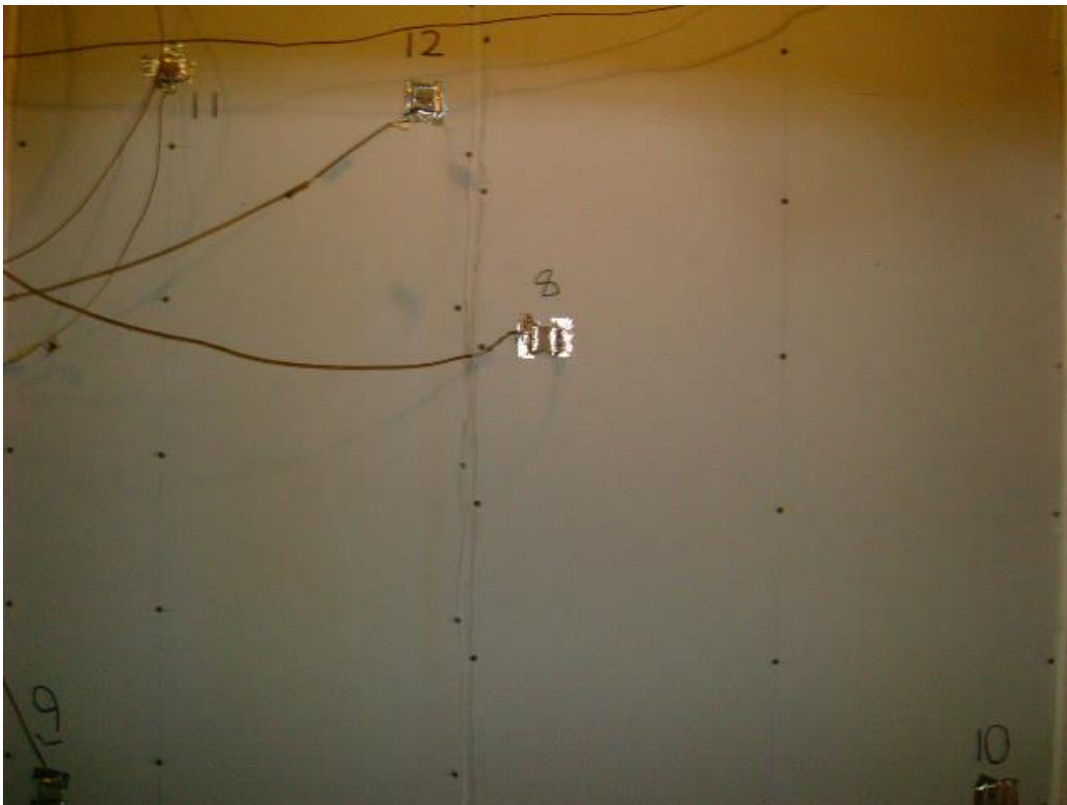
Figure 12 - Test Specimen 2 – Observation 40 Minutes

Time (min)	Face (U/E) *	Pressure (Pa)	Observation details made by Test Operator.
4	U	-	Slight smoke exiting frame/furnace seal at A-B.
9	E	8.5 – 9.5	Board blackening, surface blistering predominantly in alignment with timber vertical joint positions.
12	E	7.5	Surface blistering now covering board face.
16	E	7.5	Increase in surface marking in alignment with timber vertical joint positions.
25	E	7.5 – 8.3	Flaming on board face in alignment with 2 nd timber vertical joint position (as viewed from the fire side).
31	E	7.5	Flaming on board face in alignment with 2 nd and 3 rd timber vertical joint positions.
35	E	9 – 9.5	Flaming on board face in alignment with all timber vertical joint positions as viewed from the fire side).
35	U	9 – 9.5	No change from 4 minutes.
38	U	9.7	Slight smoke exiting from puncture (circa 10mm vertical slit) in plaster face in centre of board.
40	U	8.1 – 8.8	As above see Figure 12

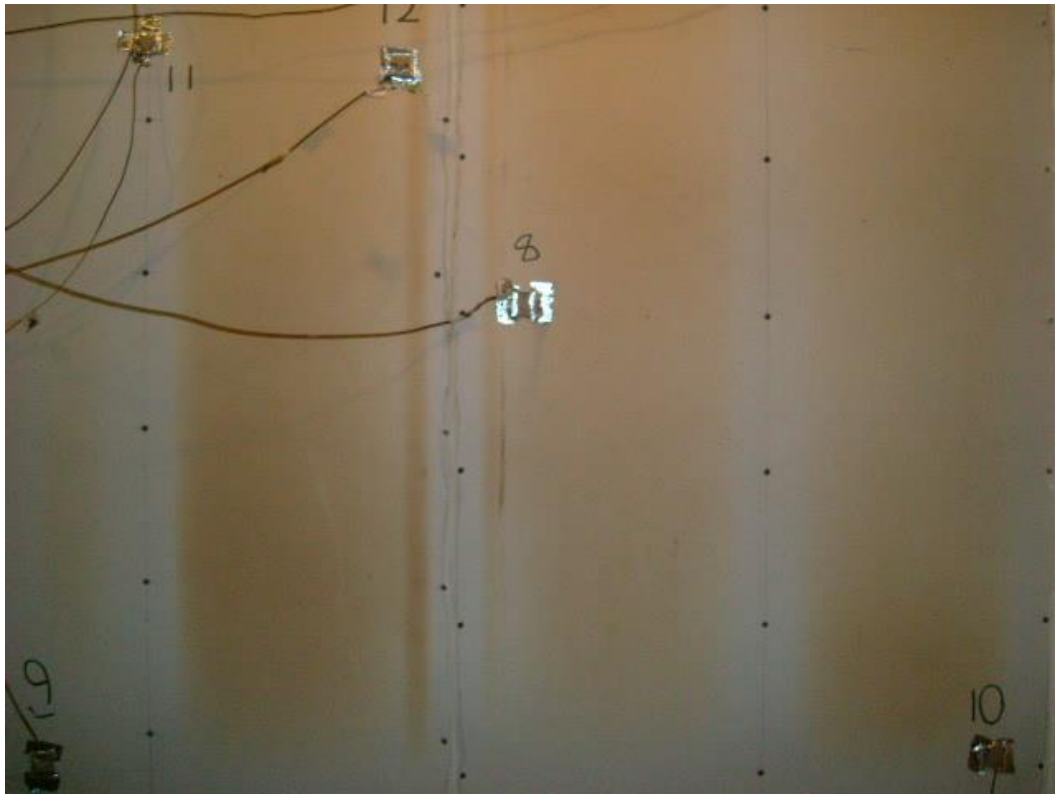
Figure 13 - Test Specimen 2 - Observation 44 Minutes

42	U	7.9 – 8.6	Slight brown discolouration in centre panel sections between timber joint positions.
44	U	7.9 – 8.6	As above see Figure 13
47	U	7.9 – 8.6	Further discolouration see Figure 14
49	U	Pressure Surge	Temporary surge in pressure noted
49	E	7.9 – 8.6	Extreme flaming now evident on board face in alignment with all timber vertical joint positions as viewed from the fire side).
50	U	9.5	Plasterboard face showing closed cracks in A-C area between timber joint positions.
51	U	9.3	Glowing evident in crack areas see Figure 15
53	U	8.5 – 9.3	Open cracks now evident on board face at A-C area between timber joint section.
53	E	8.5 – 9.3	As noted at 49 minutes – board still intact.
54	U	8.5 – 9.3	Flaming at position noted at 53 minutes, see Figure 16 Integrity failure – test terminated.

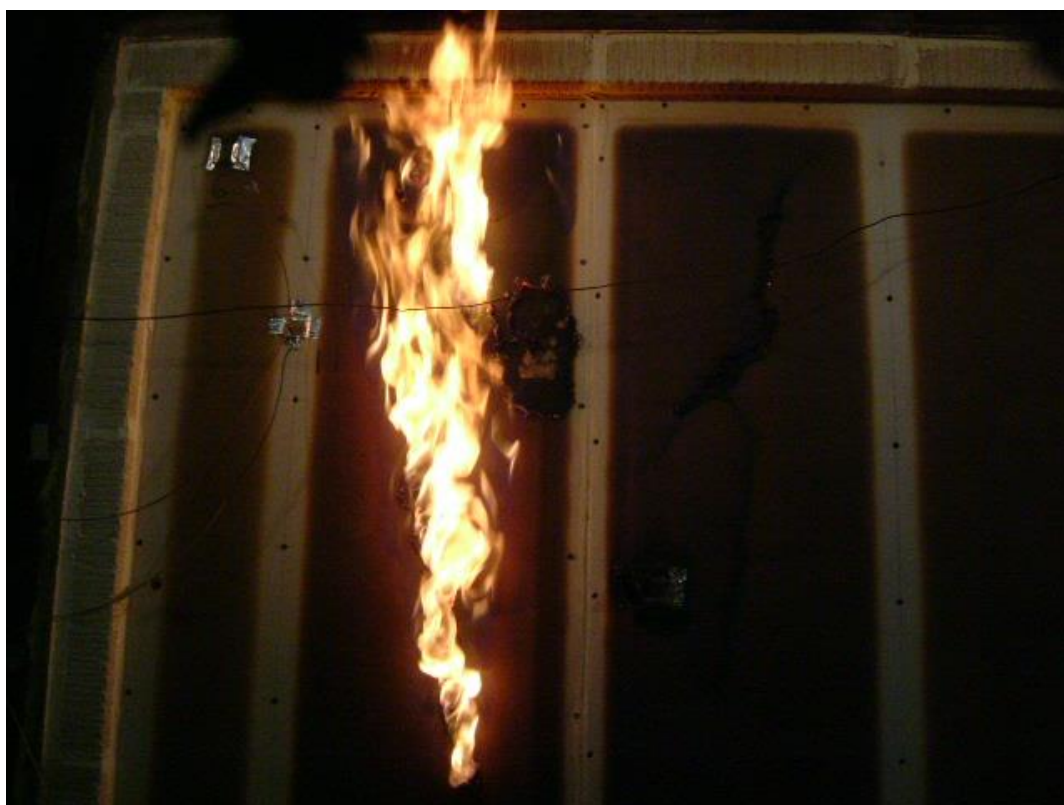
Figure 16 - Test Specimen 2 Observation at Failure

- Flaming was seen on the exposed face from positions relative to the timber upright joints. This was evident although the Magboard S-Line board was “intact” apart from blistering and surface lines.
- The failure at the exposed face was in an area not supported by the vertical timber joints.
- Post test observation showed that the Magboard S-Line board was still fixed to the frame although damage to the timber joints was evident. The Magboard S-Line board fell from the frame during the furnace emptying

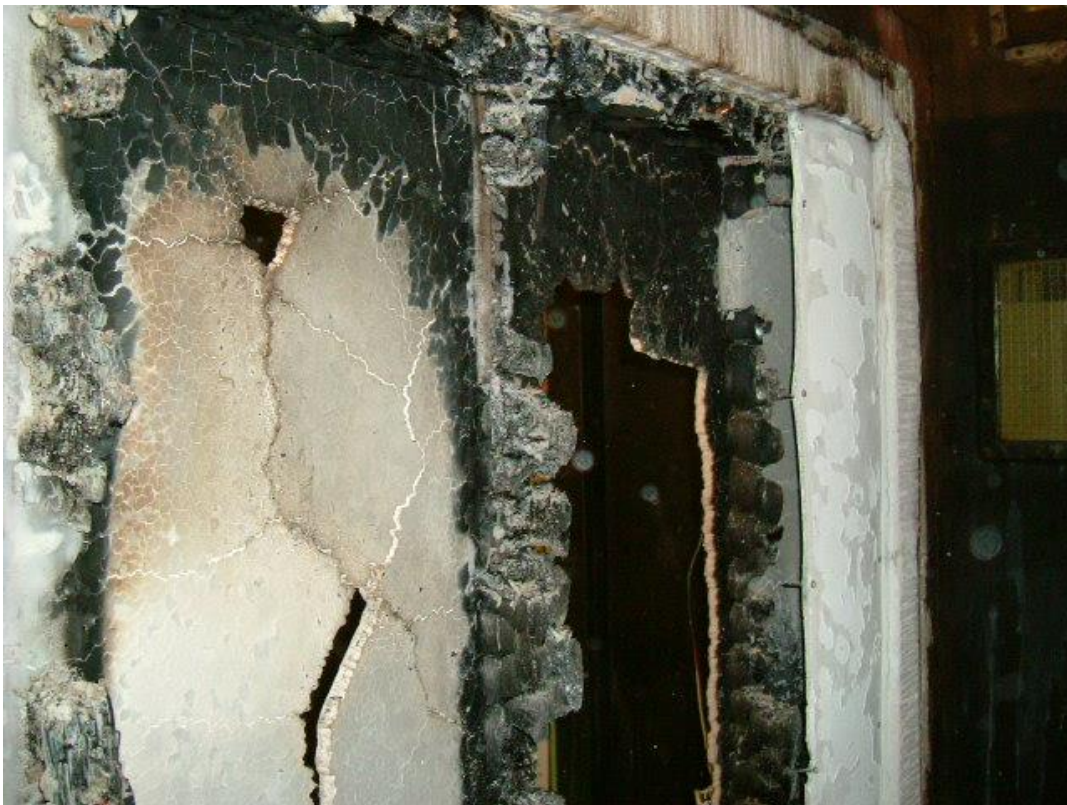
Figure 18 - Test Specimen 2 - Post Test Observation - Fire Side

procedure. The final Figure 18 shows the post test observation after the board had collapsed.

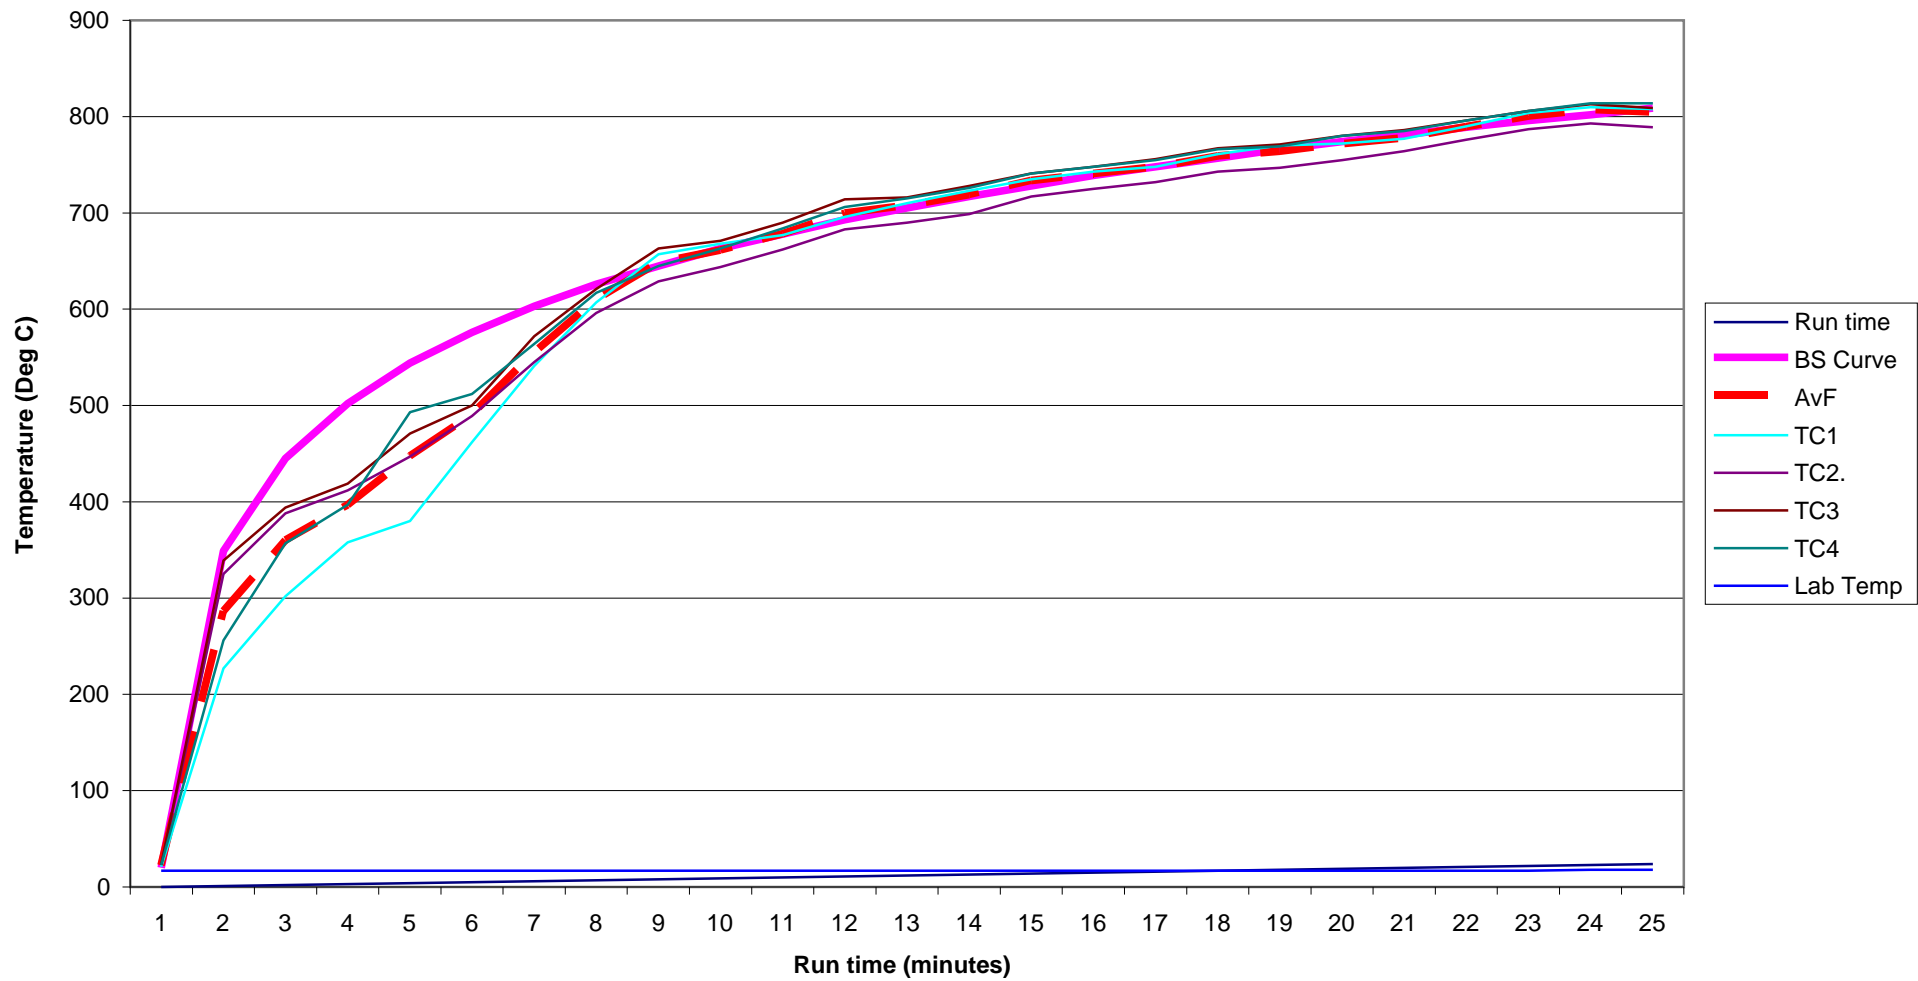
Furnace temperature was monitored using four type K mineral insulated thermocouples positioned equidistantly across the furnace opening. The average temperature of the four thermocouples was controlled to the limits specified in BS 476 Part 20: 1987 and BS 476 part 22: 1987 Section 10.4.3. Recorded data is in the APPENDIX.

**CERAM Fire Test reference: P04191ASKR – Magboard Benelux BV - Test Specimen 1 - 23/09/04 -
Furnace Thermocouple Data**

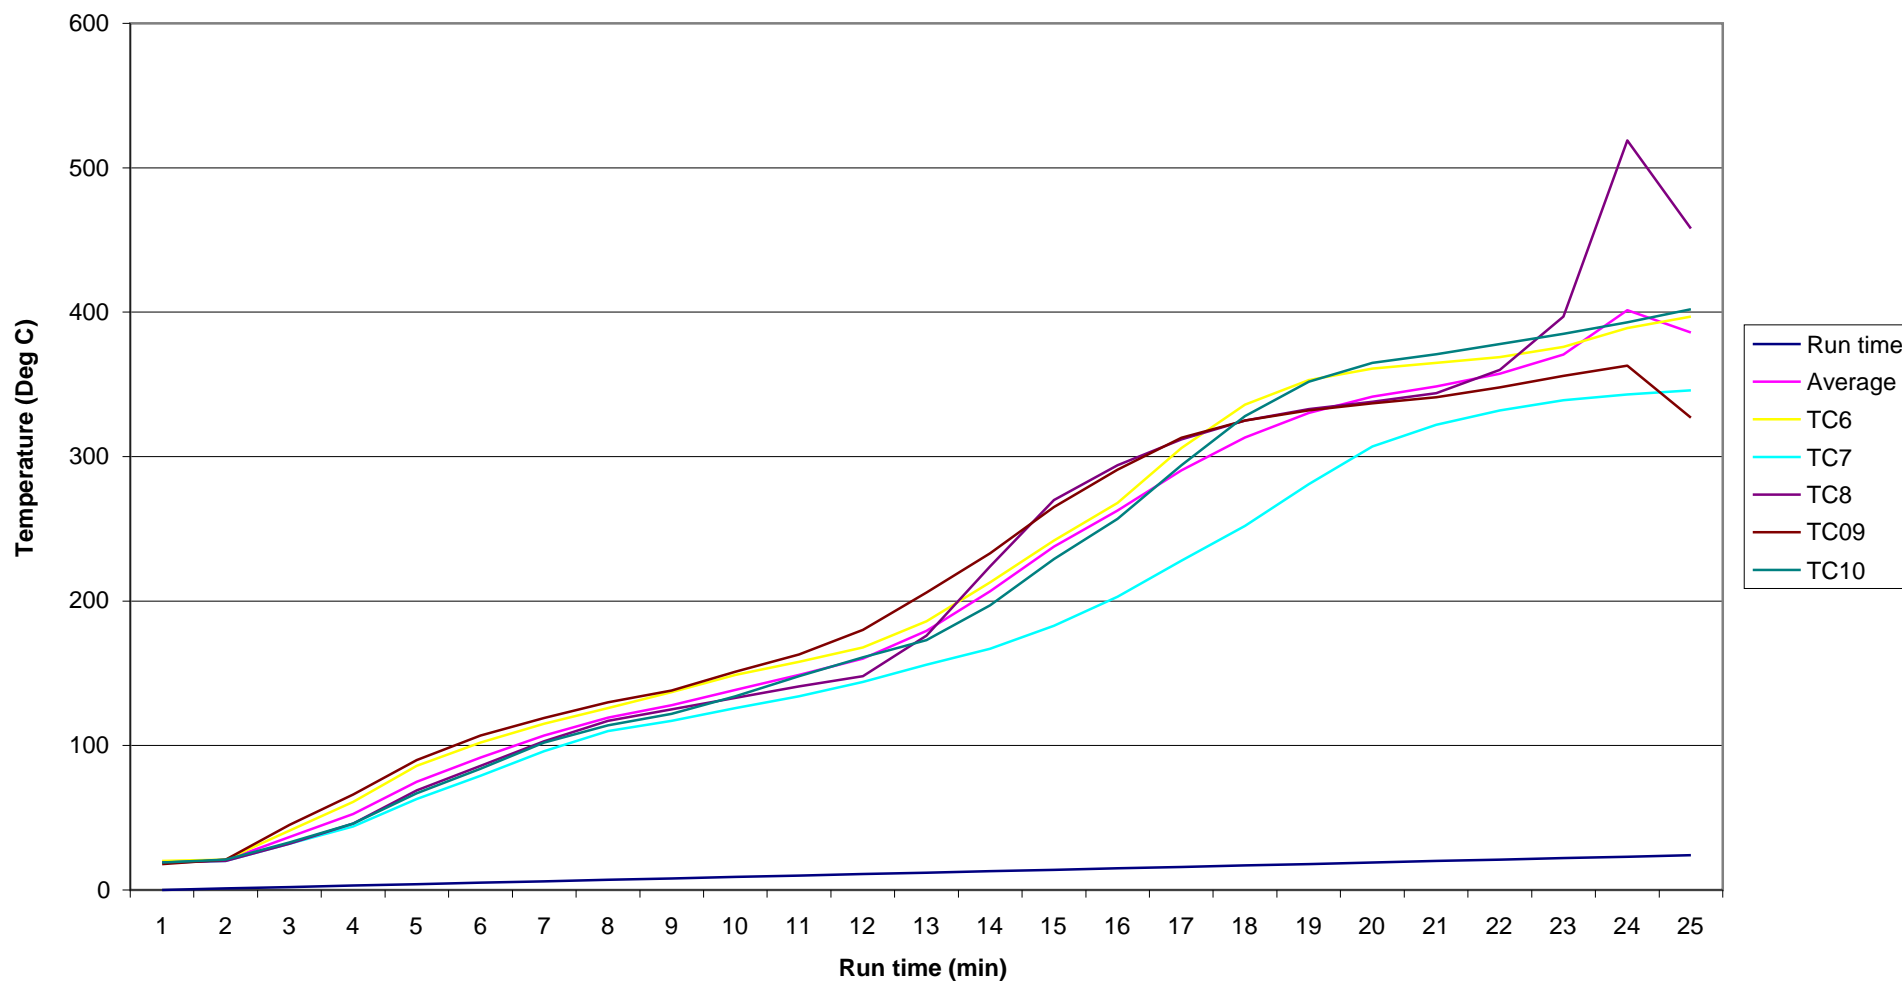
When the test specimen was subjected to temperature conditions specified in BS 476 part 20:1987 and a positive pressure equivalent to 8.5 Pa (± 2.5 Pa) at a height of 1 m, the system maintained the insulation criteria for 11 minutes and integrity criteria 23 minutes. Insulation failure occurred when the average temperature of the thermocouples attached to the non fire side reached a temperature of 160°C at 12 minutes. Integrity failure occurred when the cotton pad was ignited when applied to the specimen.

**CERAM Fire Test Ref: P04191ASKR - Magboard Benelux BV - Test Specimen 1 - 23/09/04 -
Specimen Thermocouple Data**

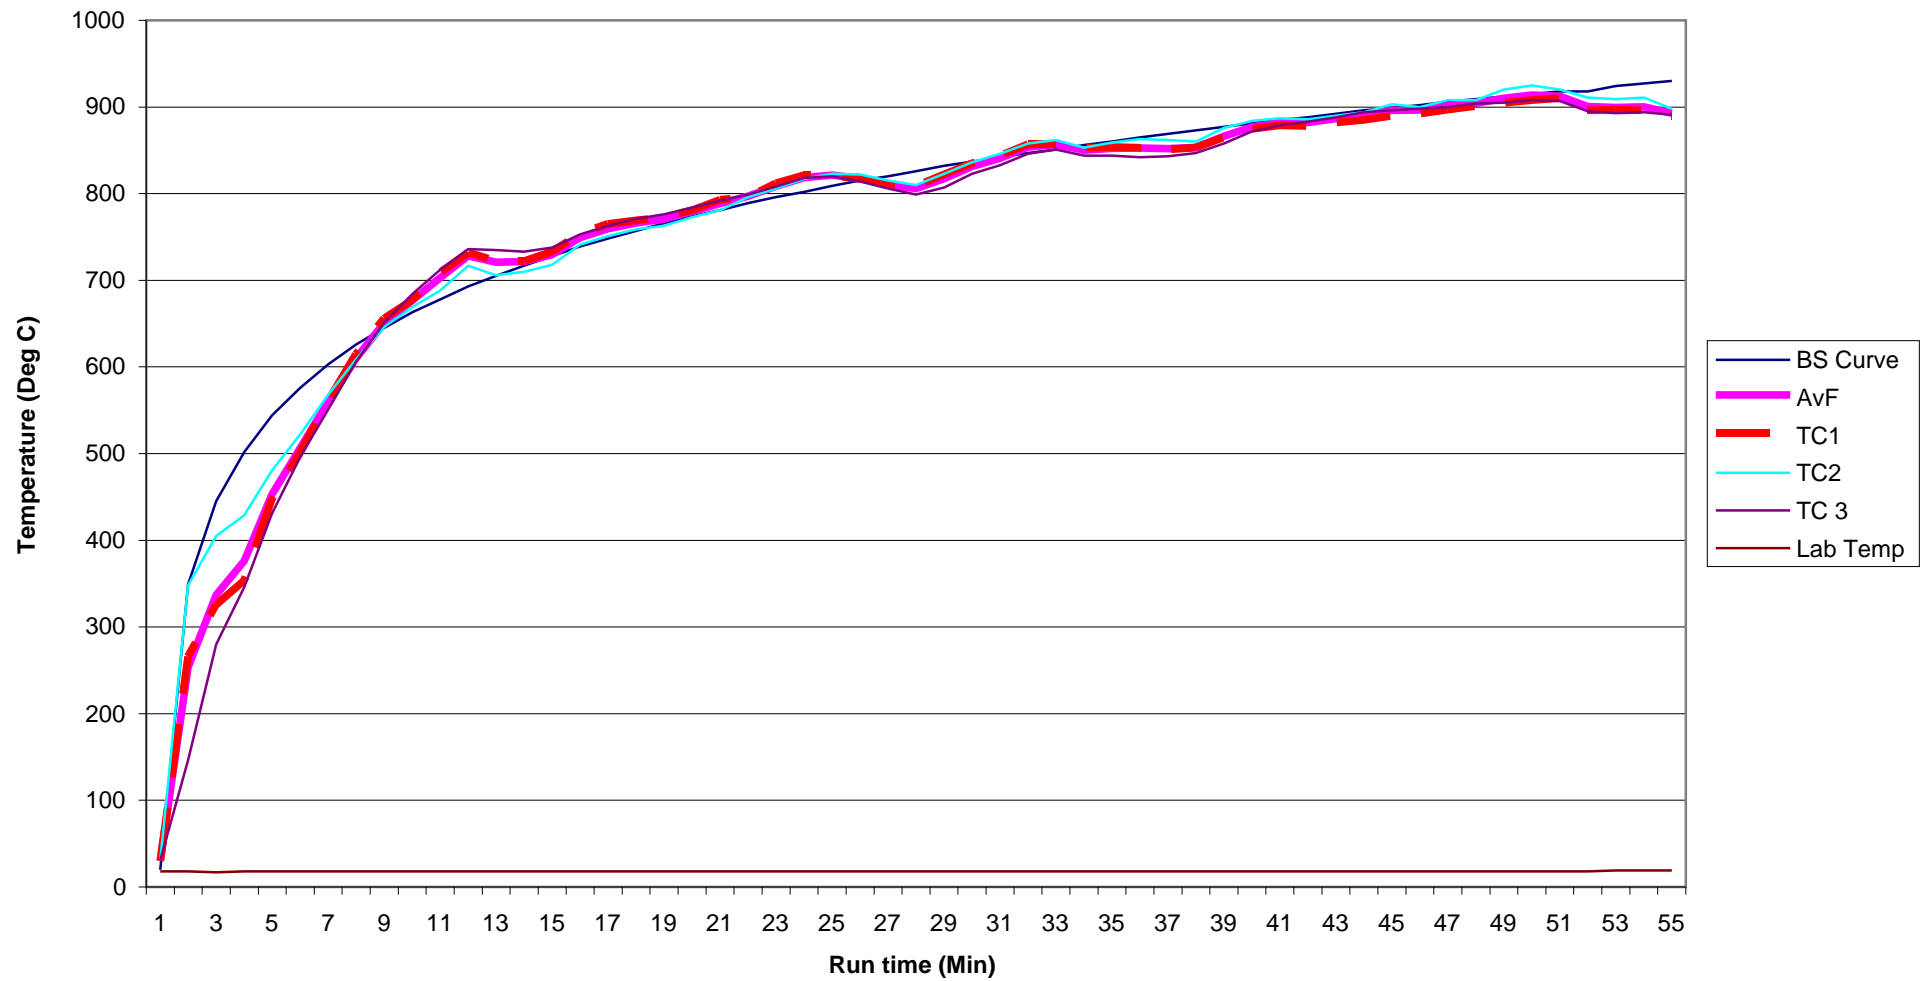
CERAM Fire Test Ref: P04191ASKR - Test Specimen 2 - Magboard Benelux BV - 23/09/04 - Furnace Thermocouple Data

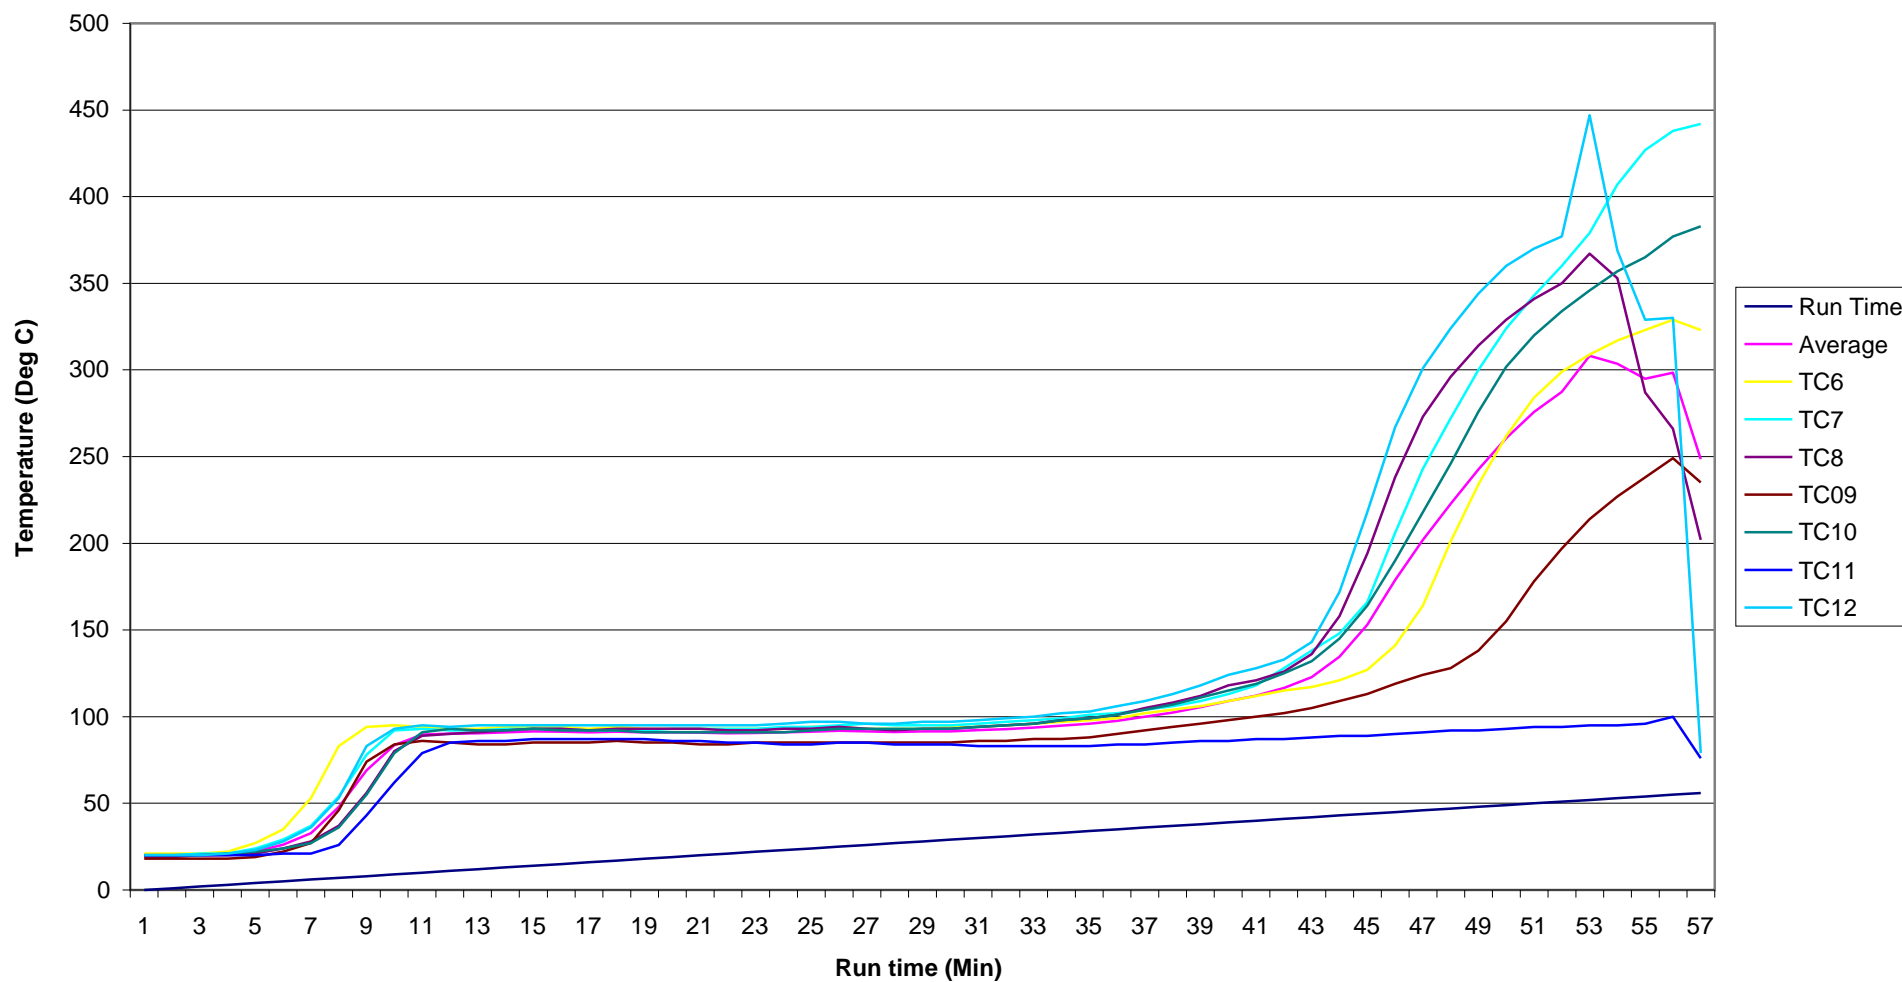
When the test specimen was subjected to temperature conditions specified in BS 476 part 20:1987 and a positive pressure equivalent to 8.5 Pa (± 2.5 Pa) at a height of 1m, the system maintained the insulation criteria for 43 minutes and integrity criteria 53 minutes. Insulation failure occurred when thermocouple 12 reached a temperature of 218°C at 44 minutes. Integrity failure occurred when flaming was observed on the specimen face.

CERAM Fire Test Ref: P04191ASKR - Test Specimen 2 - Magboard Benelux BV - 23/09/04 - Specimen Thermocouple Data
